5/019/072

POGM RECEIVED
4-10-96

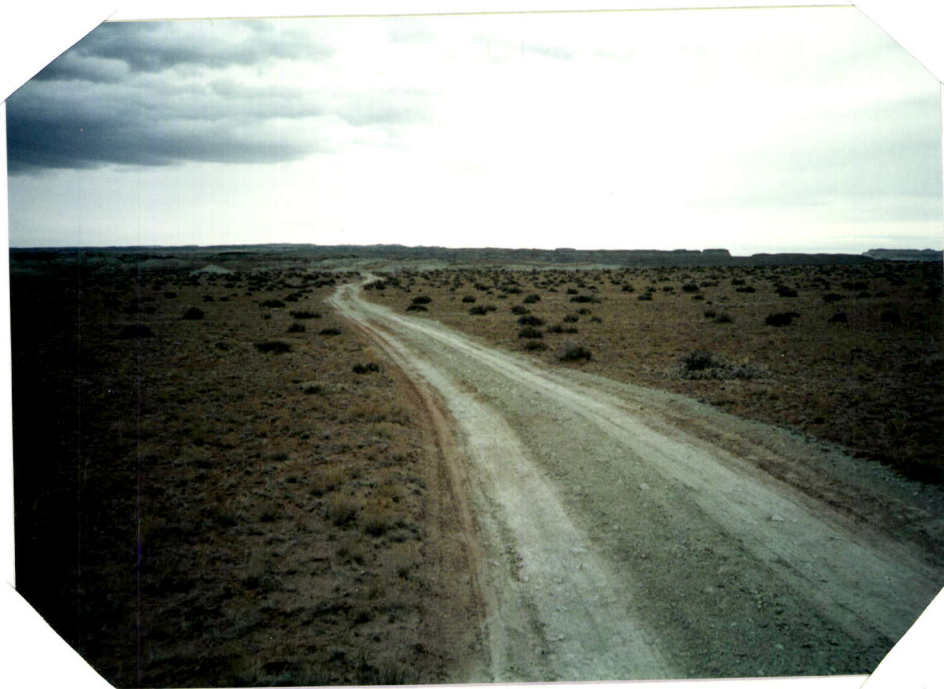
A. Part of the access road on which Western Clay Company's contractor is applying shale as road base in T.24S., R.7E., Section 15 under notice, UTU-73779. 4-2-96.

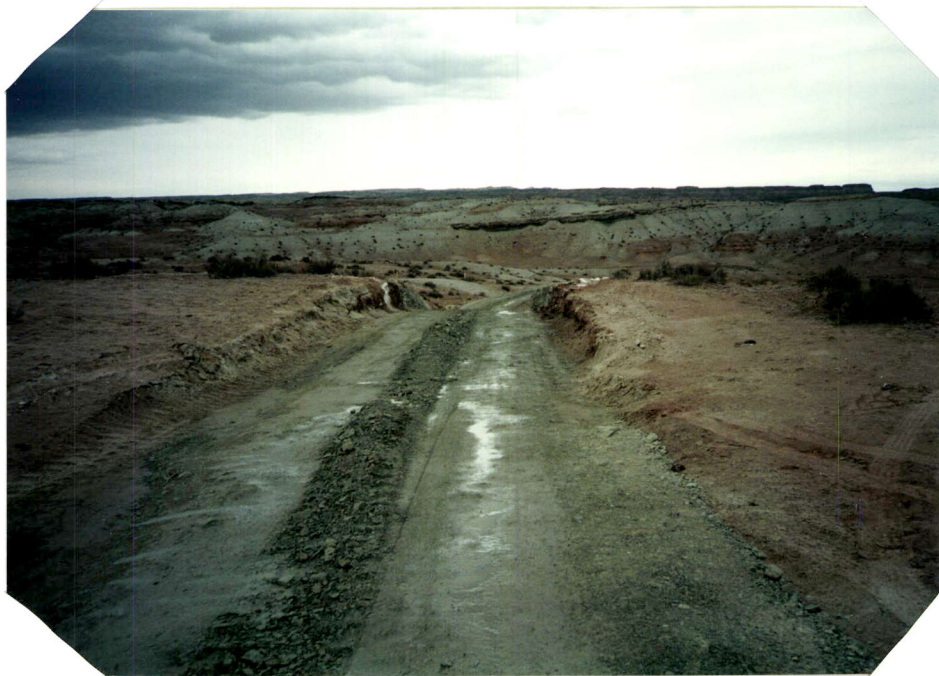
B.. Second realignment on Western Clay Company's access road to their gypsum mine in T.24S., R.7E., Section 15, notice UTU-73779. 4-2-96.

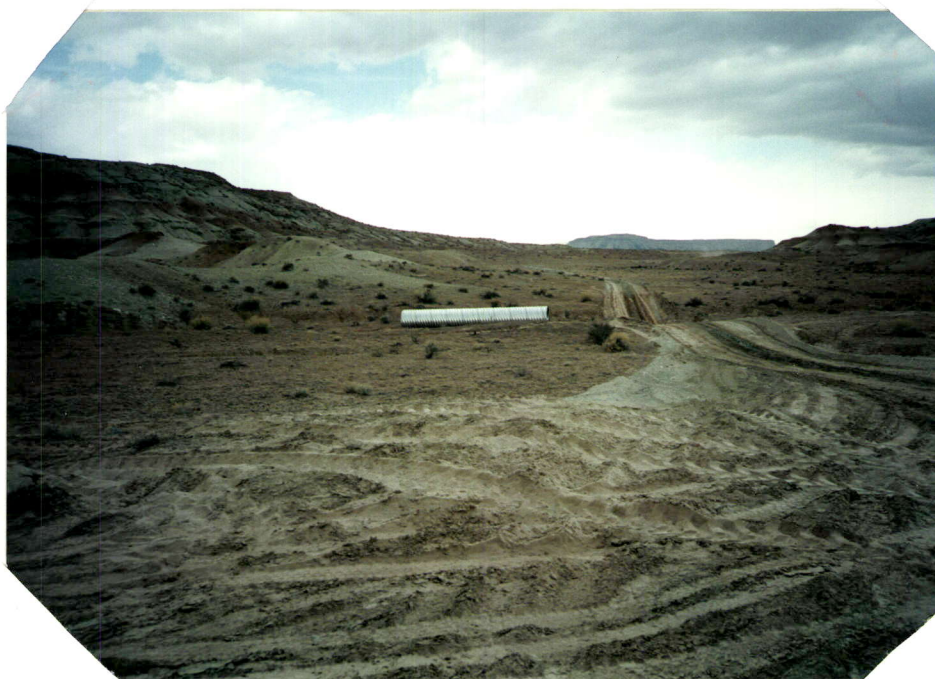
n C. Culvert for the first wash crossing on the access road, Western Clay Company, Notice UTU-73779, in T.24S., R.7E., Section 23. 4-2-96.

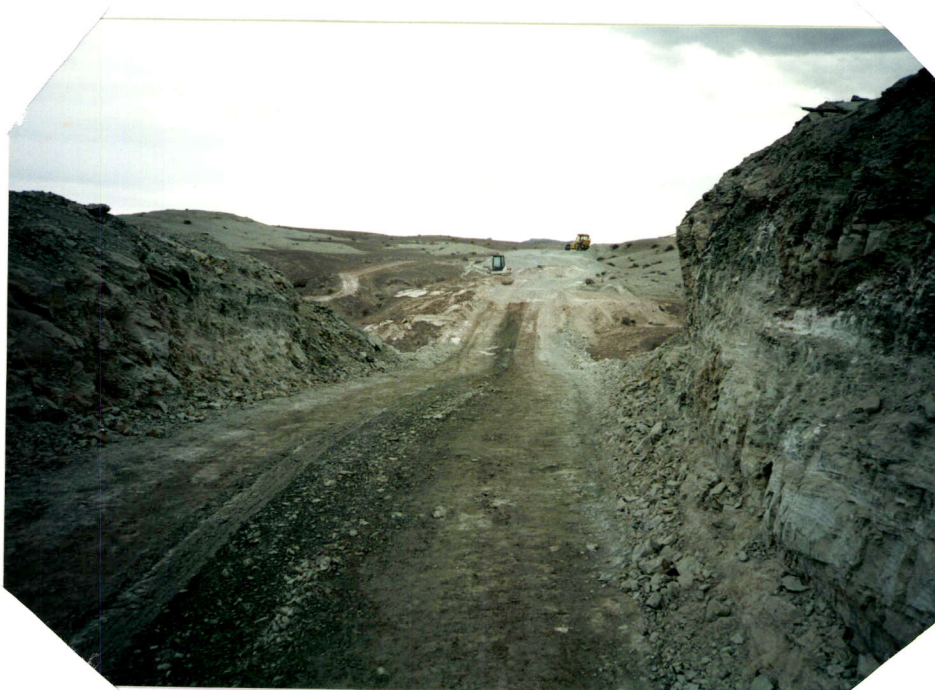
D. Entrance to the Western Clay Company gypsum mine in T.24S., R.7E., Section 23, notice, UTU-73779. 4-2-96.

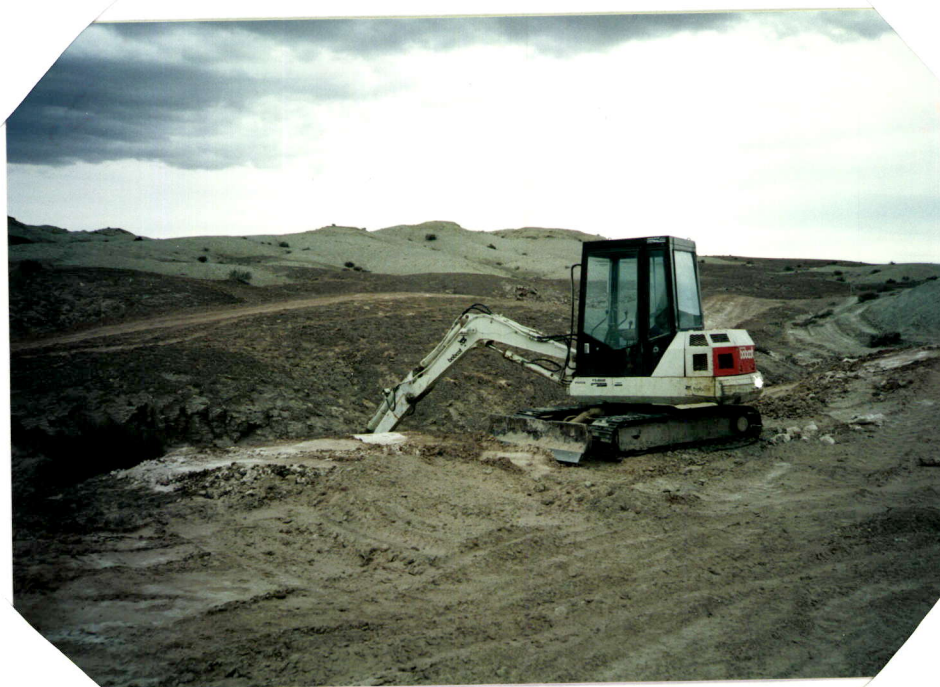
E. Track-mounted backhoe located at the western end of the mine in T.24S., R.7E., Section 23, notice, UTU-73779. 4-2-96.

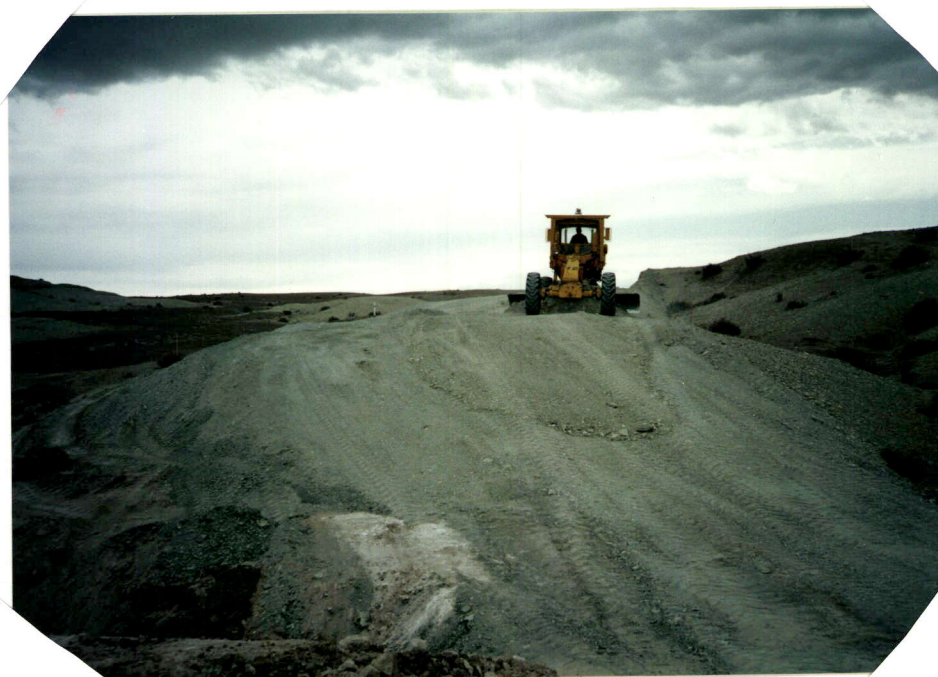
F. Grader removing shale overburden in T.24S., R.7E., Section 23, the western portion of the mine, notice UTU-73779. 4-2-96.

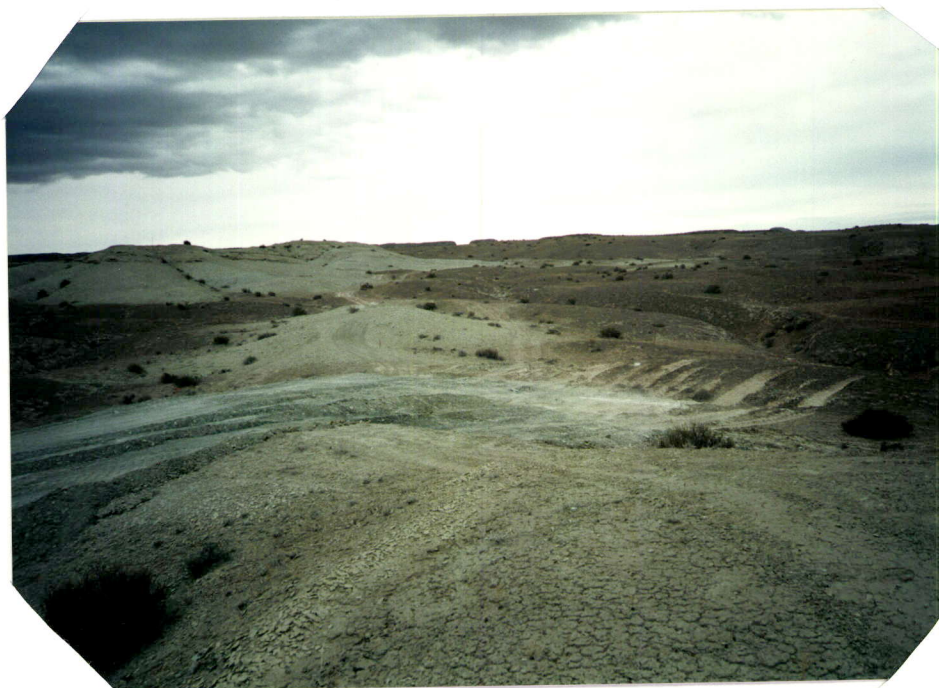
F. Eastern end of the surface disturbance in the gypsum mine, Western Clay Company notice, UTU-73779 in T.24S., R.7E., Section 23. 4-2-96.

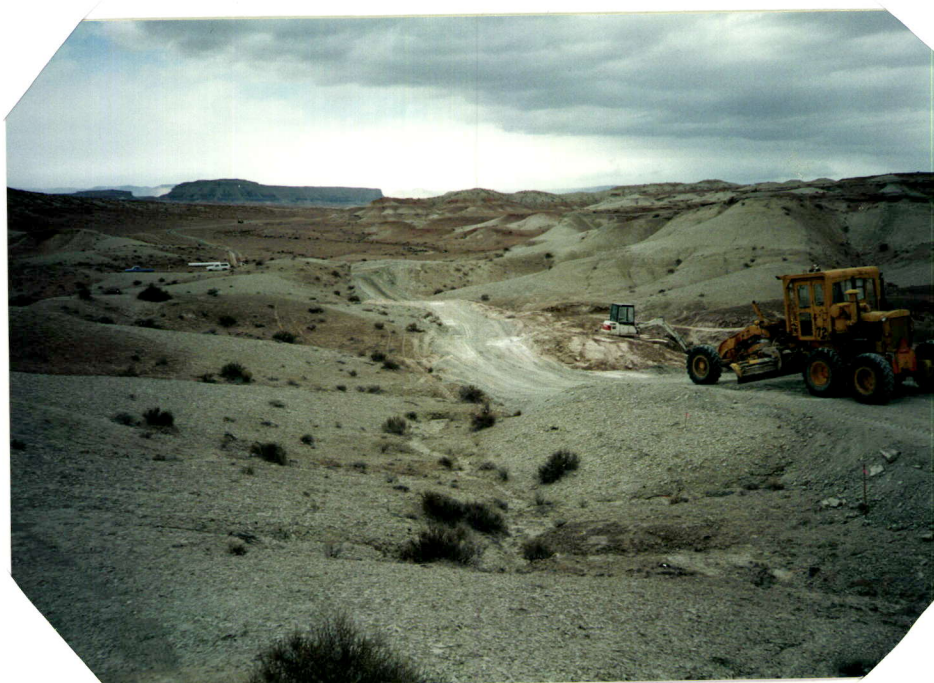
G. Looking west over the western part of the mine and the access road in T.24S., R.7E., Section 23, notice UTU-73779. 4-2-96.

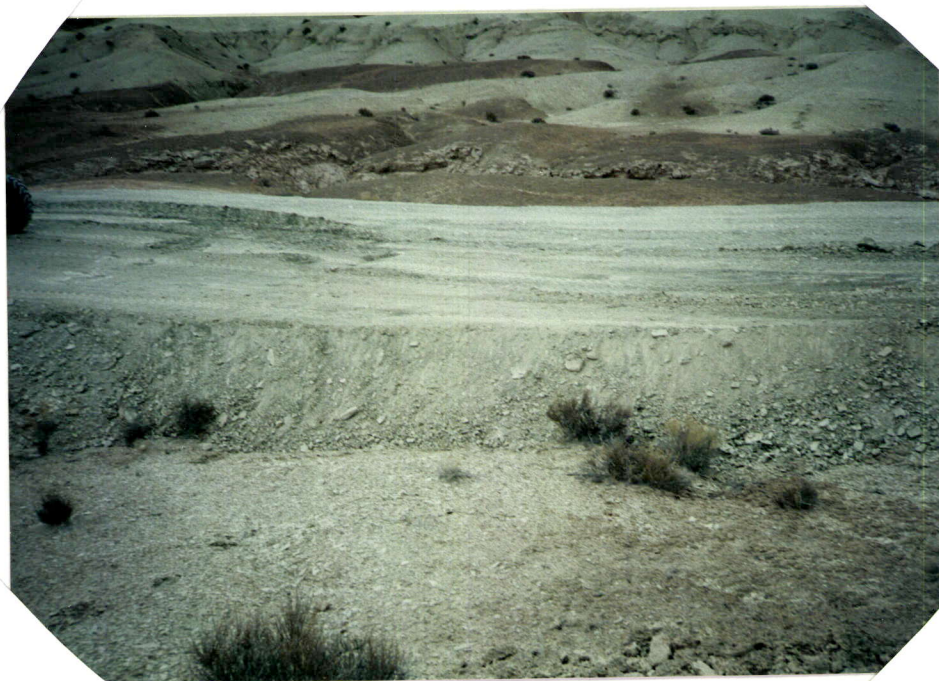
H. Side view of the access road just west of the gypsum mine,
Western Clay Company notice UTU-73779 in T.24S., R.7E.,
Section 23. 4-2-96.
